PHYTOTOXICOLOGY
ASSESSMENT SURVEY
OF THE
MAY 1990 FIRE
AT THE
BRANTFORD ONTARIO HYDRO
TRANSFORMER STATION

MARCH 1992

ARB 019-91-PHYTO

William I. Gizyn
Phytotoxicology Section
Air Resources Branch
Ontario Ministry of the Environment

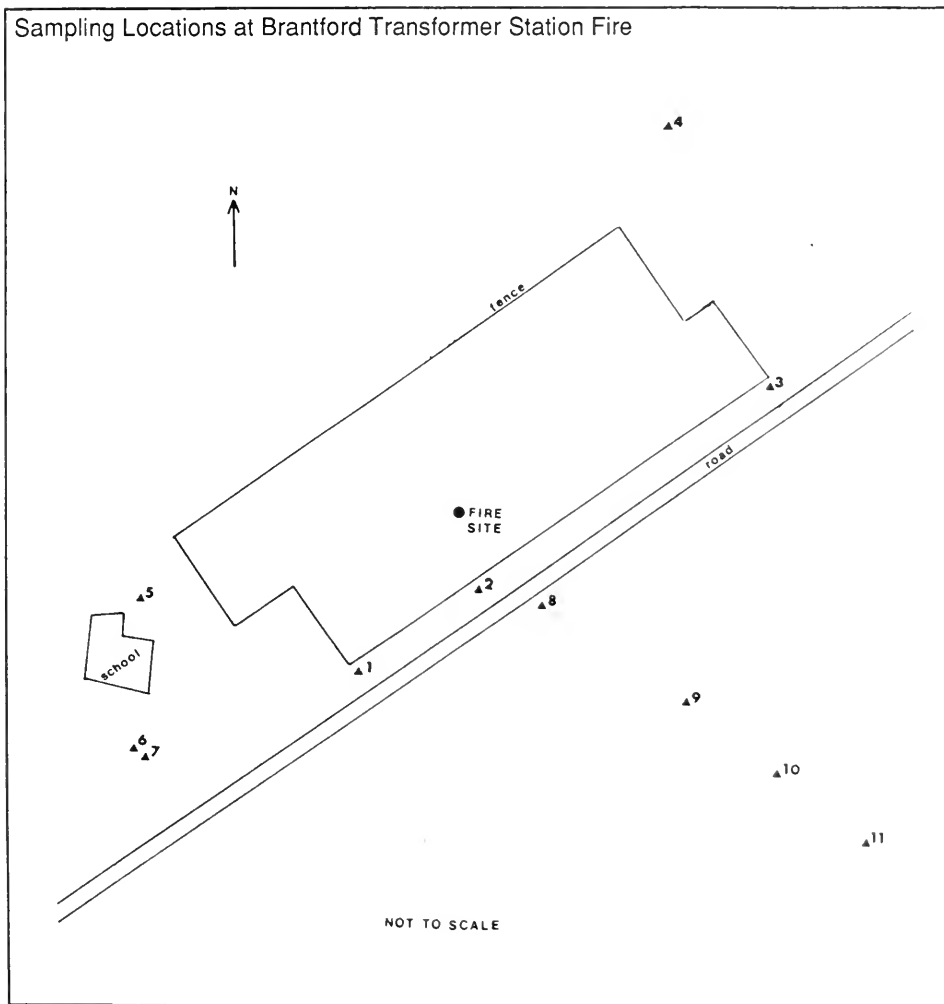
The following sketch map illustrates the relative locations of the school and field to the station and the transformer. This figure also identifies the locations of foliage and soil samples taken during the investigation.
